Docket No. 217 – Development and Management Plan Inspection

Northeast Utilities Service Company Certificate of Environmental Compatibility and Public Need for the construction of a 345-kV electric transmission line and reconstruction of an existing 115-kV electric transmission line between Connecticut Light and Power Company's Plumtree Substation in Bethel, through the towns of Redding, Weston, and Wilton, and to the Norwalk Substation in Norwalk, Connecticut.

Date: November 17, 2005

Location: 345kV Underground Route

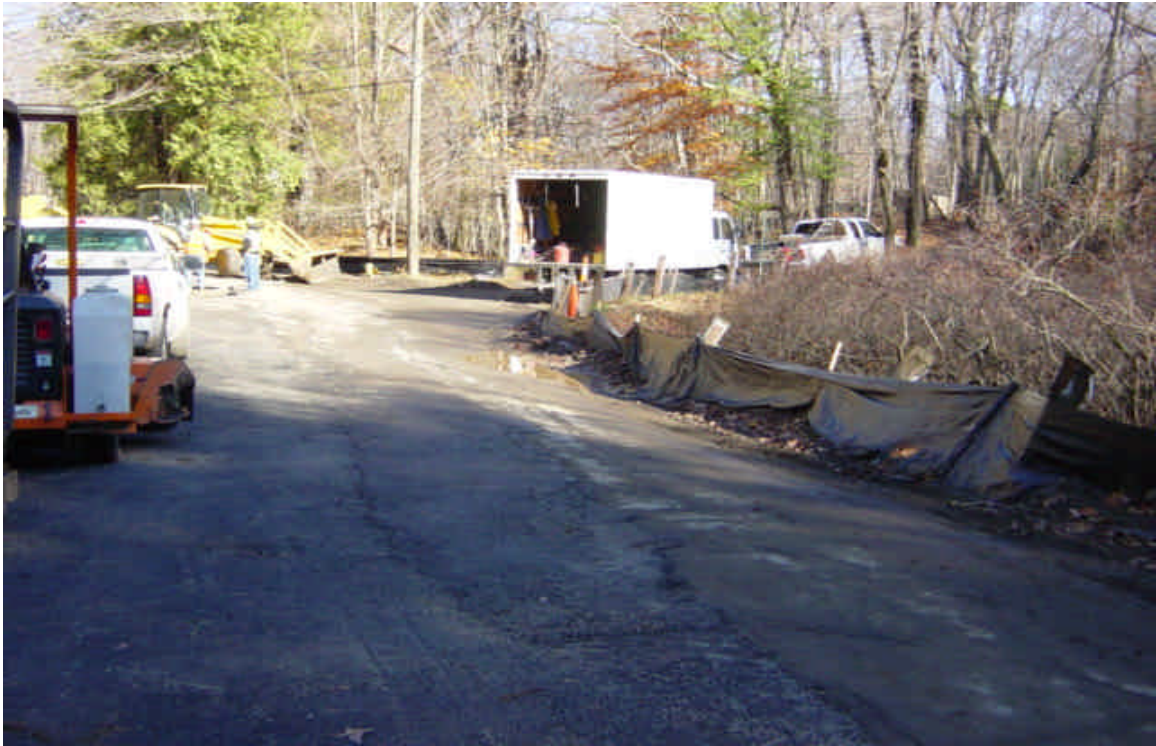
345kV (Umpawaug Rd Daywork): View of the work in the vicinity of Wayside Lane with silt fence that has been installed appropriately along the wetland edge. 11/17/05

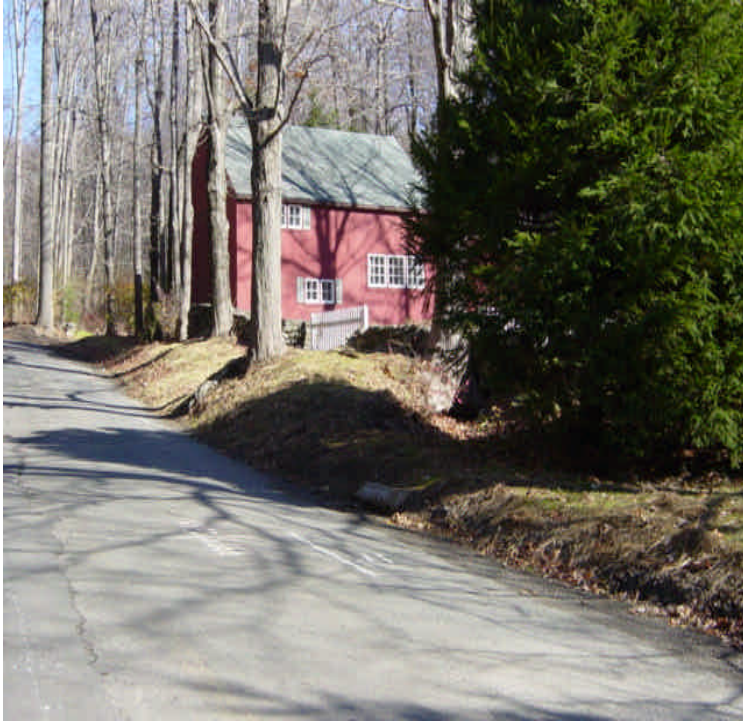
Photo on the left shows some reseeded/restoration efforts. Photo on the right shows a view of the trenching efforts leading north from Wayside Lane. 11/17/05

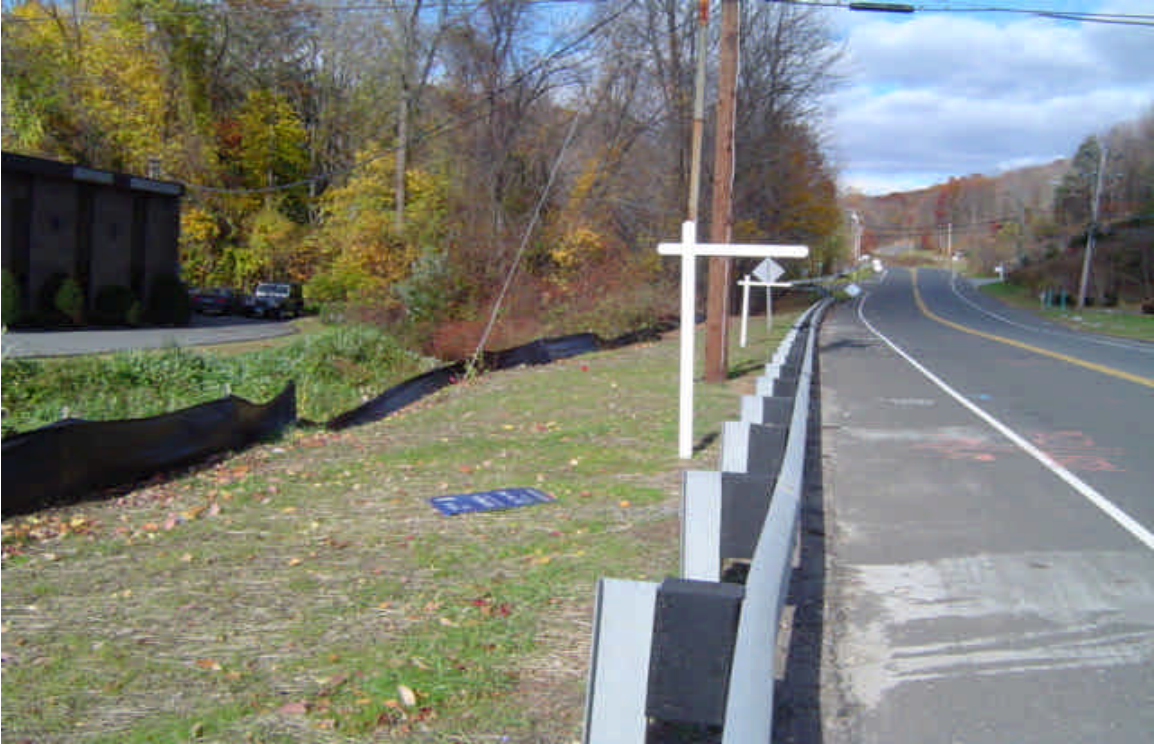
345kV (Route 107- Georgetown Jack and Bore): View looking along Rt. 107 at the grass re-growth at a restored area just north of the Georgetown Deli. 11/17/05

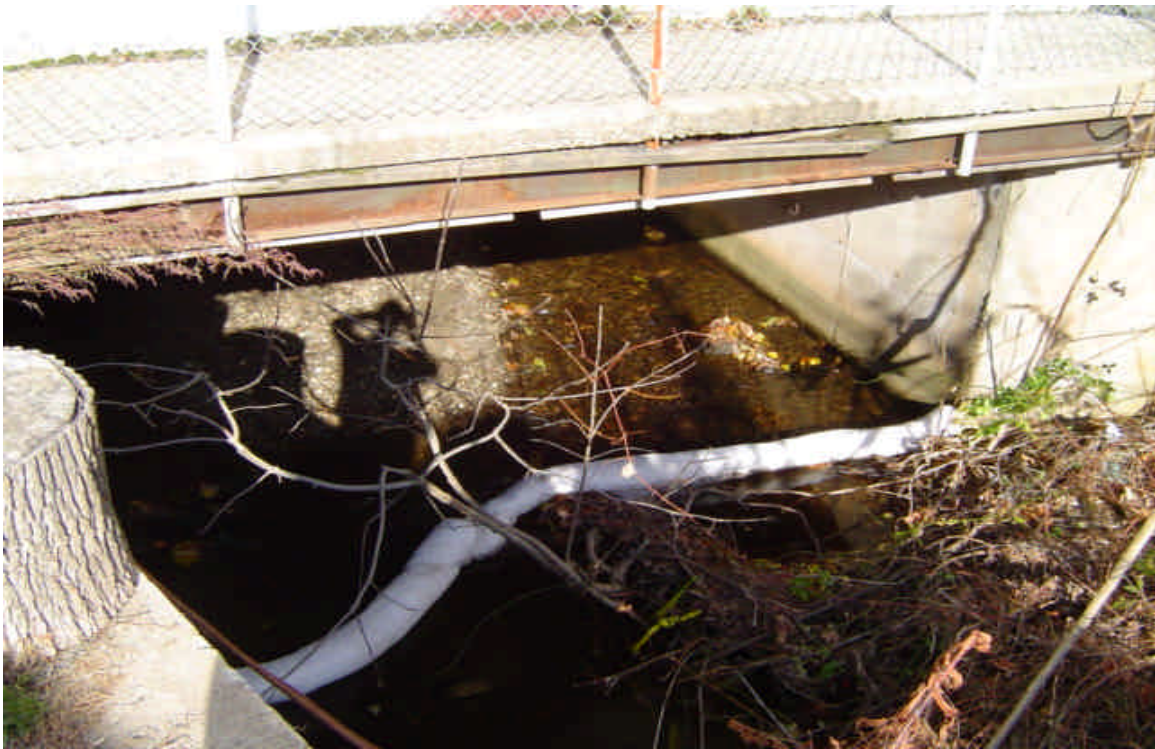
View of the boom still in place across the downstream portion of the brook. Turbidity issues were not noted in the stream.

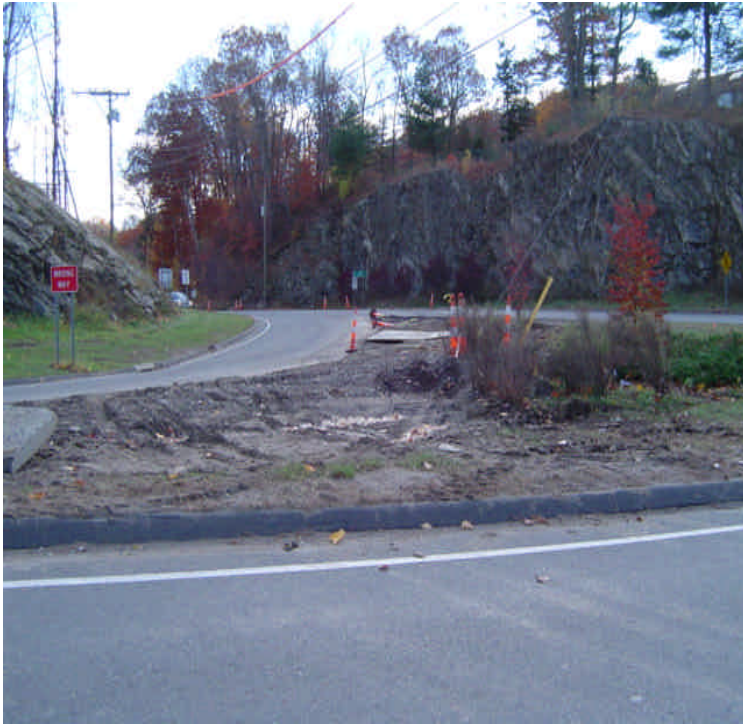
345kV (Rt. 7): Photo on the left shows the bare/disturbed soil at the Rt 107/7 intersection where haybales or fabric should be placed on the catch basin. Photo on the right shows the silt fence down around the storage yard near #848 Danbury Rd. due to landowner activities. 11/17/05

Areas of Inspection	Observation	Recommended Action
<p>Erosion and Sediment (E&S)Controls (continued)</p> <p>Route 7</p>	<ul style="list-style-type: none"> - Attempt to control all catch basins as well as outlet points off the road when work is in the vicinity. Some areas were still lacking haybales including the Rt. 107/7 island and the Catalpa Rd. area. 11/10-11/17/05 - Stockpiles have been removed from the Catalpa Rd. area. 11/17/05 -If not already done so, the jack and bore area should be mulched/stabilized as soon as practicable. 11/10-11/17/05 - Restore or landscape the Rt. 107/7 island. 11/17/05 -It needs to be confirmed whether the sediment accumulation noted in the stream at the J& has been removed. 11/10-11/17/05 - At the HDD, the detention area was holding a significant amount of turbid water likely due to containment issues with the drilling muds. E&S controls beyond the basin could use some maintenance. Several spots had haybales in disrepair and sediment accumulation was noted under the fence in one location. 11/10-11/17/05 - The portion of the site to the east may still need to be encompassed in more silt fence. Especially as an apparent leak of drilling muds had migrated in this direction. 11/10-11/17/05 - Leaks of mud and washwater was noted near the return tank. 11/10-11/17/05 	<ul style="list-style-type: none"> - Make sure that haybales are placed in the catch basins during the work and continue to maintain them until bare soil is gone. Filter fabric is also an accepted measure if haybales are difficult to maintain. 11/17/05 - None at this time. Use E&S controls if piles remain for more than the day.11/17/05 -Continue restoration efforts along the roadway where work is complete. 11/17/05 -The least impacting way to remove the sediment is likely by hand/shovel. It should be done carefully and with the instream controls in place. 11/10-11/17/05 -Continuing to repair this outer erosion control lines is important as some sediment is still finding its way out to that point. 10/27-11/17/05 Containment issues with the drilling muds also needs attention- the basin should not be holding turbid washwater. 11/17/05 - Extend the silt fence to enclose this piece. 10/19-11/17/05 -Determine why the muds did not remain enclosed in the frac tank and make sure they remain contained. 11/17/05 - Remove any mud remaining adjacent to the silt fence and store properly. 11/17/05

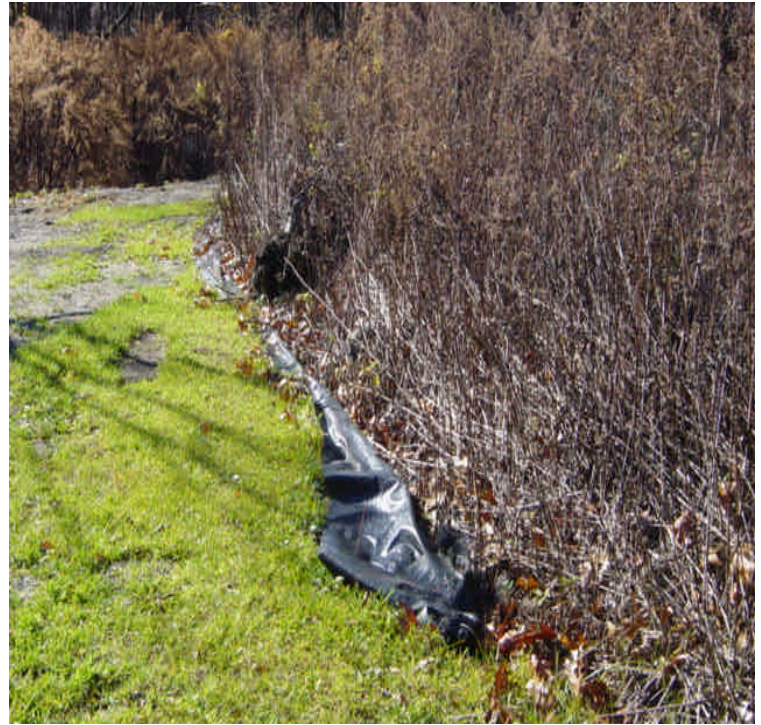
Staging, Storage, and Parking Areas	<ul style="list-style-type: none"> - The silt fence at the equipment storage yard located on property south of the Rt. 7 &107 intersection is down in some of the areas closest to the road due to landowner activities. 10/27-11/17/05 -Additional silt fence is required at the School Rd. HDD area along the eastern side of the disturbed yard, especially as drilling muds and turbid water were noted here. 11/10-11/17/05 	<ul style="list-style-type: none"> - In general, materials should be placed appropriately in storage areas or immediately adjacent to work each night. No potentially spillable materials should be left behind or out overnight. 11/17/05 -Install the additional fence as soon as possible. 10/27-11/17/05 - Keep within the limits of the

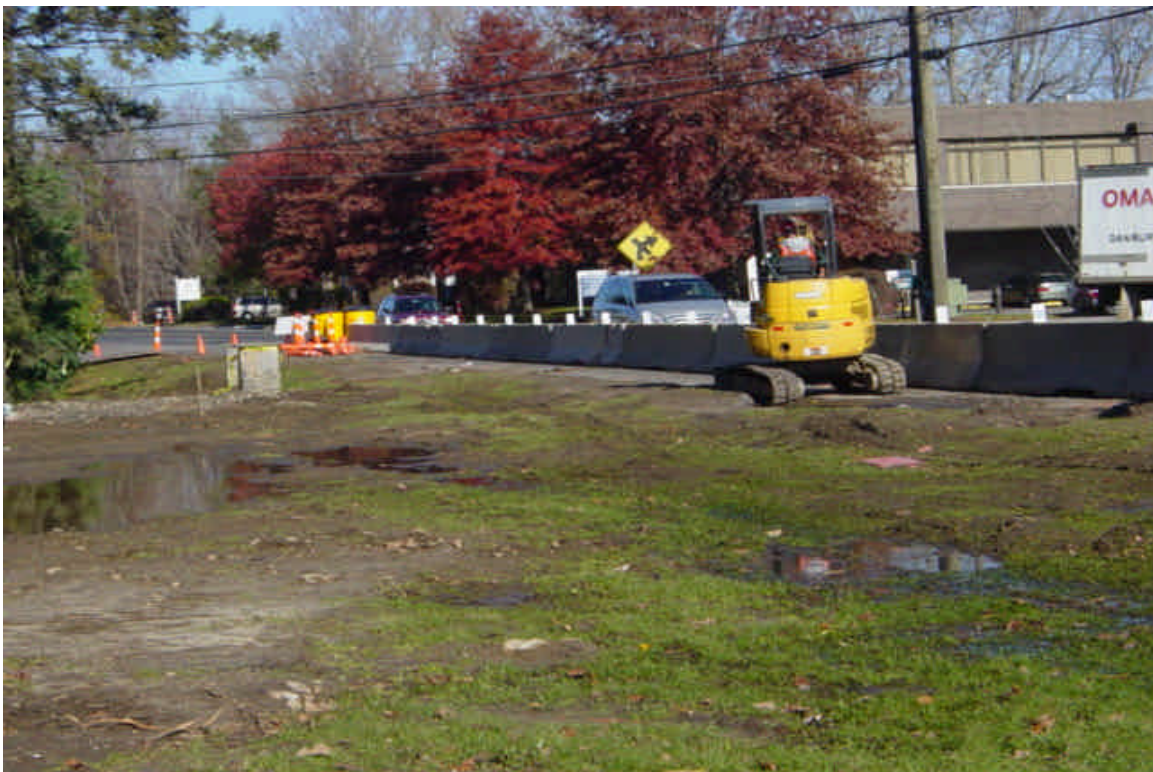
View of the work finishing up in the vicinity of Catalpa Rd. Stockpiles noted last week have been removed. 11/17/05

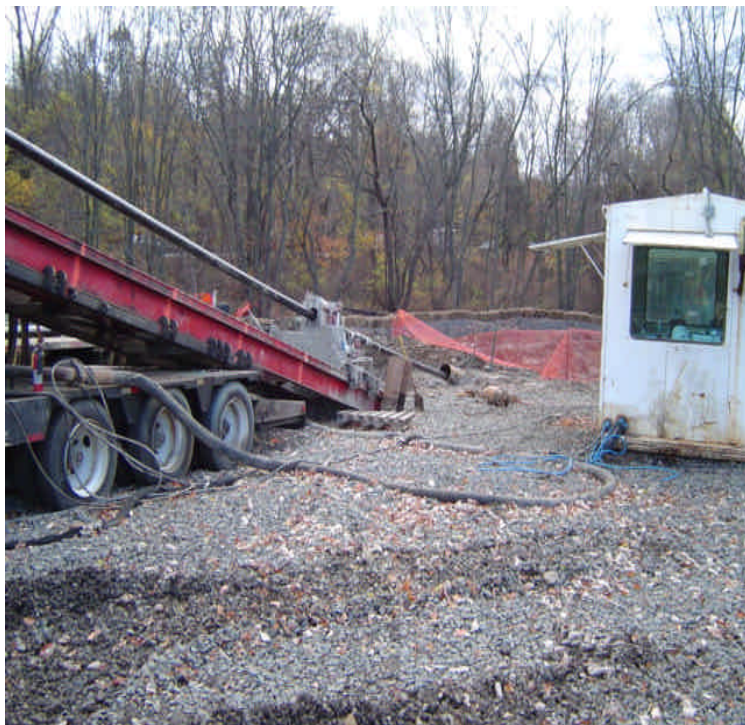
345kV (School St. HDD): Photo on the left shows the equipment for the bore operation. Photo on the right shows the return tank for drilling muds with some leaking issues still noted. 11/17/05

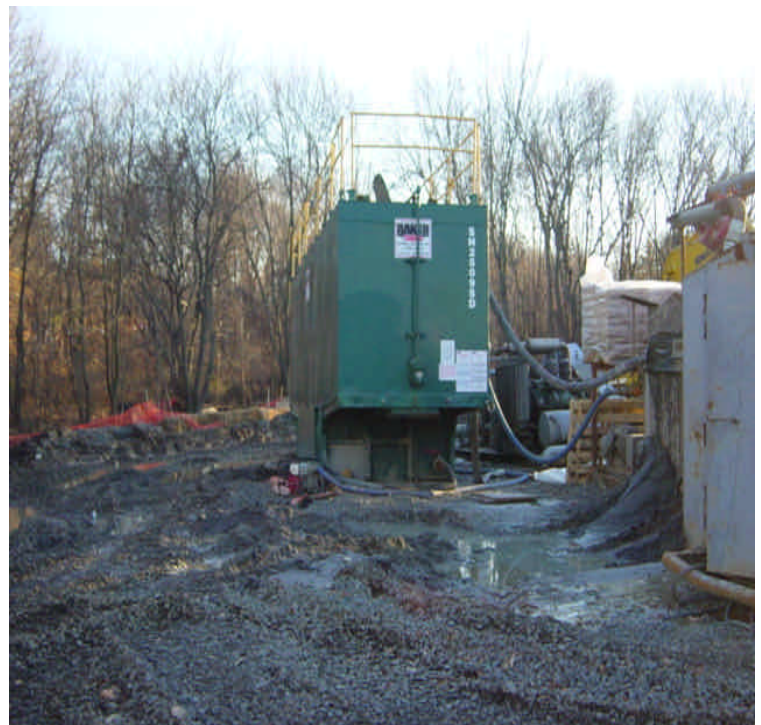
Areas of Inspection	Observation	Recommended Action
	through a silt fence and back to the stream .11/10-11/17/05	
Blasting	- No blasting is occurring on site at this time.	- None at this time.
Spills and Material Storage	- A pile of drilling muds was noticed below the holding tank and against the silt fence at the HDD site. The leaks seem to have continued and turbid wash water was noted in the basin here. 11/17/05	-Determine what is causing the overflow/loss of muds and contain them. Remove the piles that have formed and attempt to remove additional water from the basin. 11/17/05

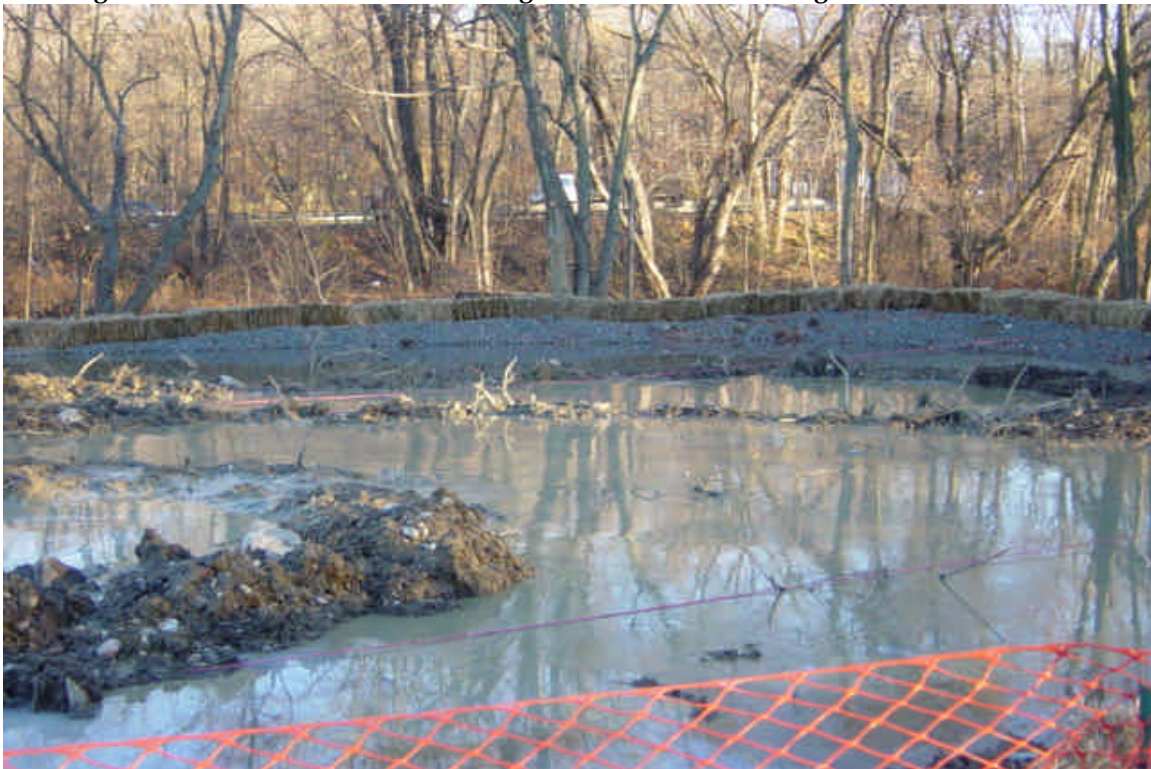
View of the basin with a large amount of standing turbid water. The turbidity issues may be related to drilling mud and washwater containment issues. 11/17/05

Areas of Inspection	Observation	Recommended Action
	<ul style="list-style-type: none"> - The wet swale at Parsons Lane was disturbed due to activities in the past few weeks week. 11/10-11/17/05 - A large bare soil sloped area was noted along the shoulder of the roadway near a stream. Erosion controls are well in place but it is still unclear whether this is associated with the 345kV work. 11/2-11/17/05 	<ul style="list-style-type: none"> - The swale needs to be restored/reshaped due to some ruts created by the equipment movement. 11/10-11/17/05 - The bare soil should be stabilized as soon as possible if this work is part of the 345kV. 11/2-11/17/05
Adjacent Wetlands and Waterways	<ul style="list-style-type: none"> -At the jack and bore near Allens Meadow Park, the stream had some remaining. accumulated sediment. It needs to be determined whether this was removed. 11/10-11/17/05 -The stream at the Georgetown Deli jack and bore remains very clear. 11/17/05 - There is some concern for the wetlands adjacent to the HDD if the basin is being used for turbid washwater from the drilling muds. A significant rainstorm will likely make this overflow. 11/17/05 	<ul style="list-style-type: none"> - Hand shoveling is likely the best solution but very careful vac truck use may be an option depending on the amount of sediment. 10/27-11/17/05 -Continue to be proactive with erosion control maintenance. 11/17/05 - Determine cause of turbidity and how to contain mud issues. 11/17/05

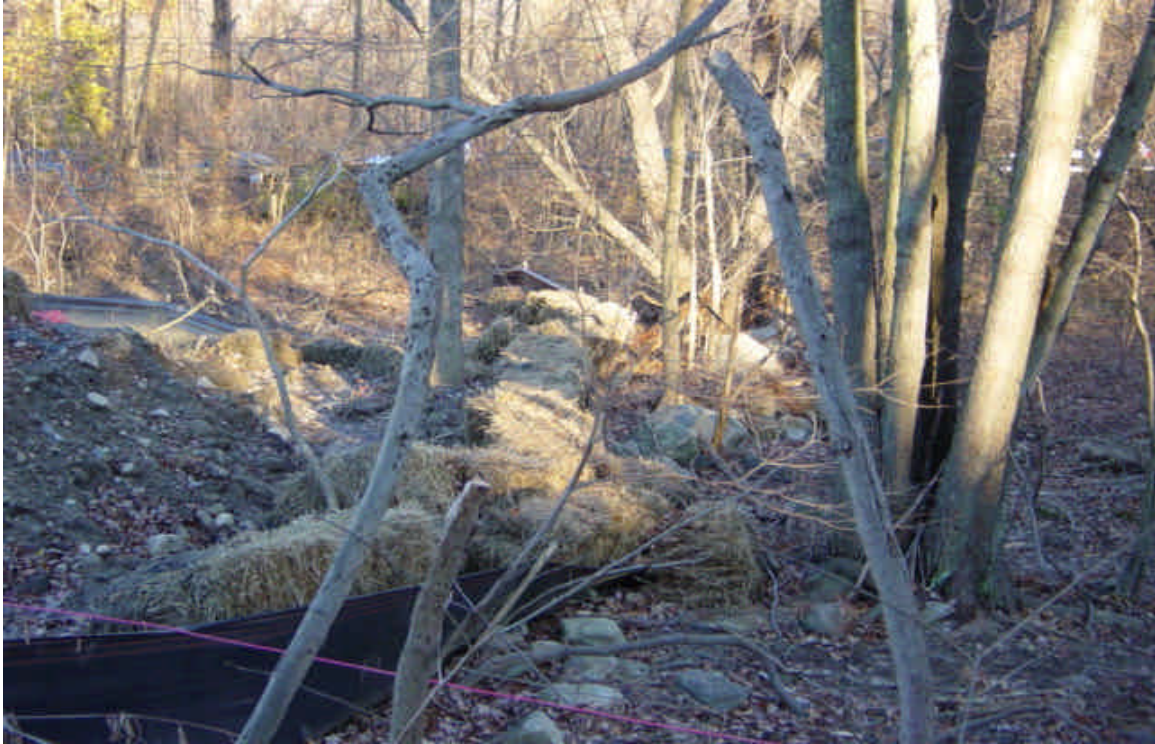
345kV (HDD): View of one of the locations where the outer perimeter erosion controls need some maintenance. 11/17/05

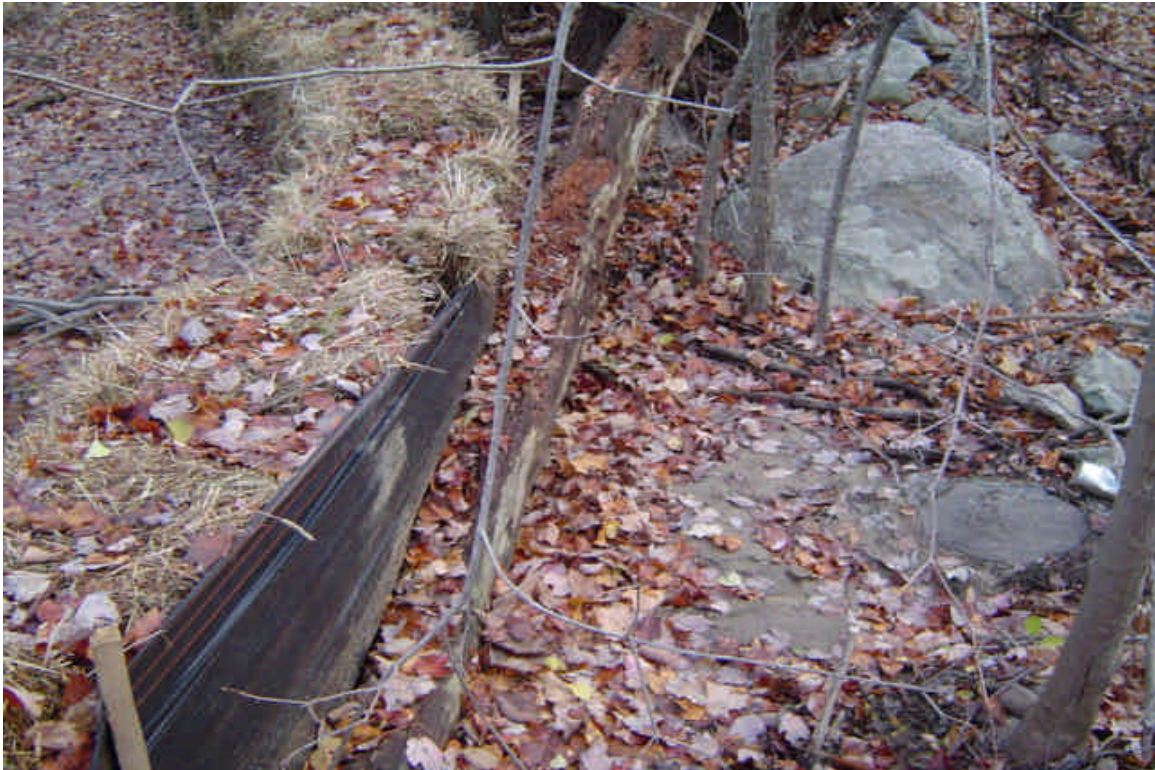
Photo of one of the spots where sediment has been able to migrate through the outer perimeter controls.
